## GAYNES LABS, INCORPORATED

**Regarding:** Dynamic and Static Loading of Server Cabinets  
Gaynes Job No. 07149      AMCO Purchase Order: PO22780

This report describes the procedures and results of the Static and Dynamic Load Tests of 2 AMCO Server Cabinets. The overall dimensions of each cabinet are 29" x 45" x 87 1/4" high. Testing was conducted at Gaynes Labs, Inc. on February 9, 2007 and was witnessed by yourself, Paul Dickson, and Steve Jarog.

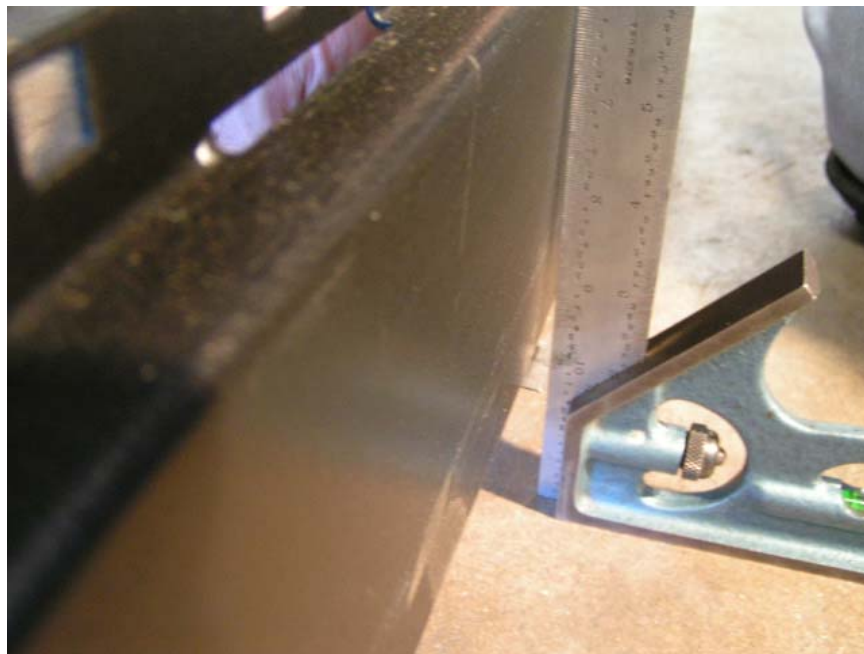
Photo 6: Measuring Technique to Determine Distortion of Vertical Alignment

The letters shown in parenthesis indicate the location of the measurements. See photo 6 for the vertical alignment measuring technique of the lower frame rails.

- (A) Front Horizontal Rail at Mid-span
- (B) Front Horizontal Rail Near Casters
- (C) Rear Horizontal Rail at Mid-span
- (D) Rear Horizontal Rail Near Casters
- (E) Left Horizontal Rail at Mid-span
- (F) Right Horizontal Rail at Mid-span

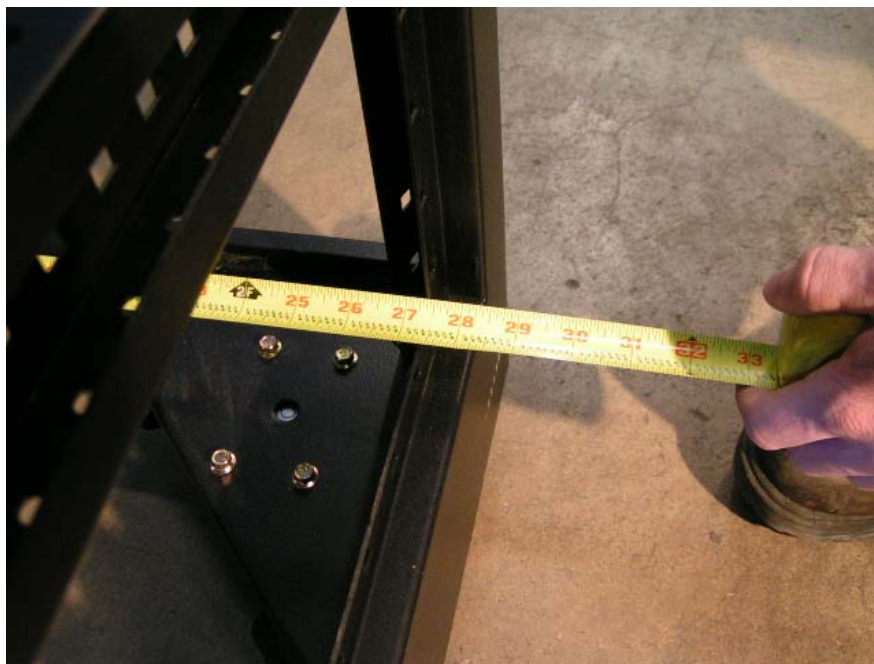
Photo 8: Measuring Technique Between the Lower Frame Rails

See photo 8 for the measuring technique of the span between the inside of the lower frame rails.

- (K) Front - Inside Span of Cabinet
- (L) Mid-span of Frame Rails - Inside Span of Cabinet.
- (M) Rear - Inside Span of Cabinet.

- (E) Front inside span between lower horizontal frame rails.
- (F) Mid-span inside span between lower horizontal frame rails.
- (G) Rear inside span between lower horizontal frame rails.

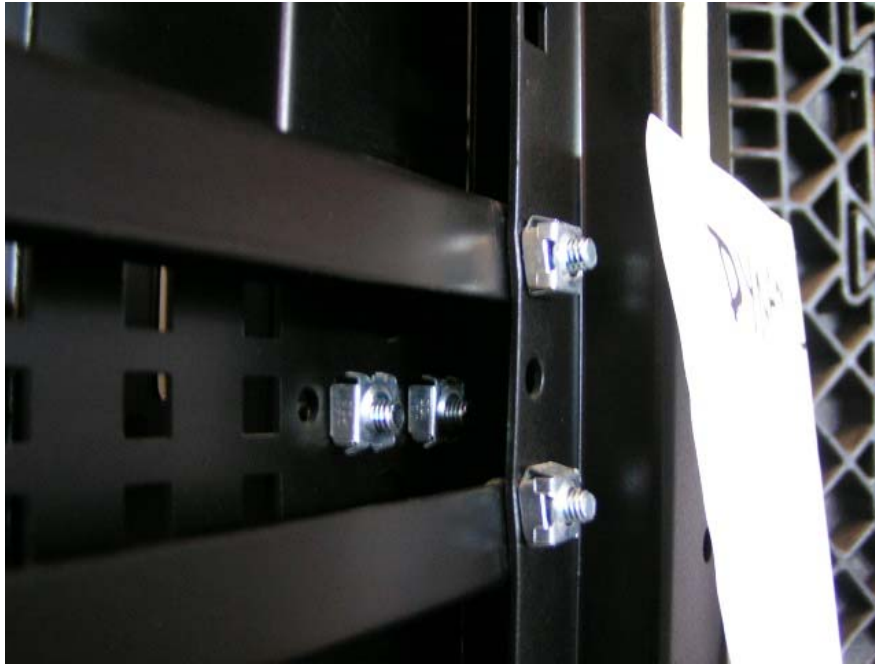
Photo 9: Distortion of vertical corner frames during 3200 lb. Dynamic Load Test.

Cabinet loaded with 3200 lbs. and rolled by straps/fork lift up a 5° incline and back to level surface. Result: Cabinet appears to be unchanged, except for minor dimensional changes as recorded, and the vertical corner frames became slightly distorted near the connecting hardware (photo 9).

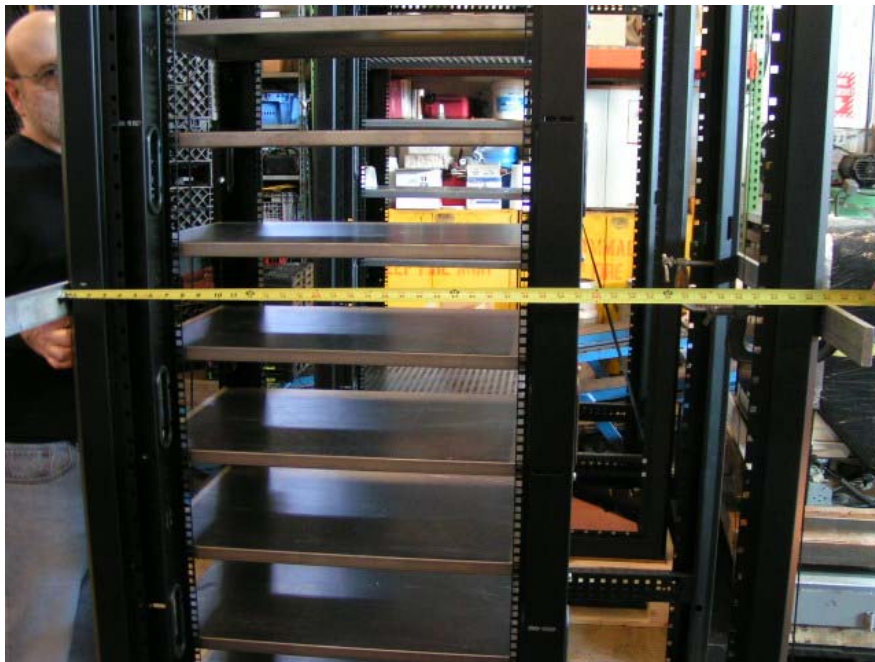
Photo 10: Measuring technique between vertical corner frames.

See photo 10 for the technique of measuring horizontally between the vertical corner frames.

- (A) Front - Outside dimension of vertical corner frame, measured at 44" from the floor.
- (B) Rear - Outside dimension of vertical corner frame, measured at 44" from the floor.
- (C) Left Side - Outside dimension of vertical corner frame, measured at 44" from the floor.
- (D) Right Side - Outside dimension of vertical corner frame, measured at 44" from the floor.

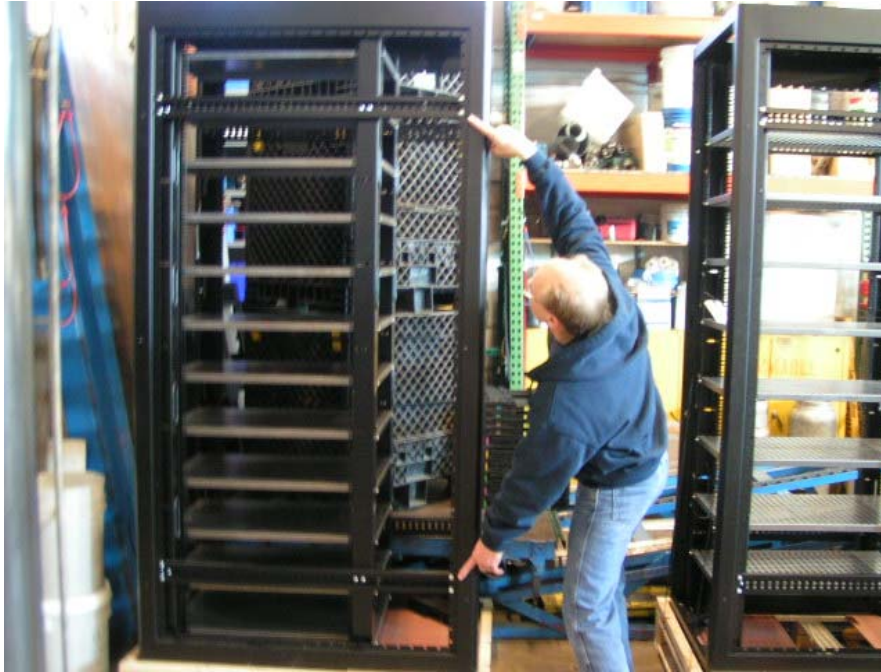
Photo 11: Location of distortion of the side rails.

Visual Inspection of the cabinet loaded with 4800 lbs. - The cabinet appeared to be unchanged during and after the loading of the 4800 lbs. with the following exceptions: The four vertical corner frames and the 2 upper and 2 lower horizontal rails that connect to the vertical corner frames became distorted during the loading of the 4800 lbs. Most of the distortion occurred to the vertical corner frame near the connecting hardware as shown in photos 12, 13, and 14. The distortion of the rails was greater at the front connections than at the rear connections.

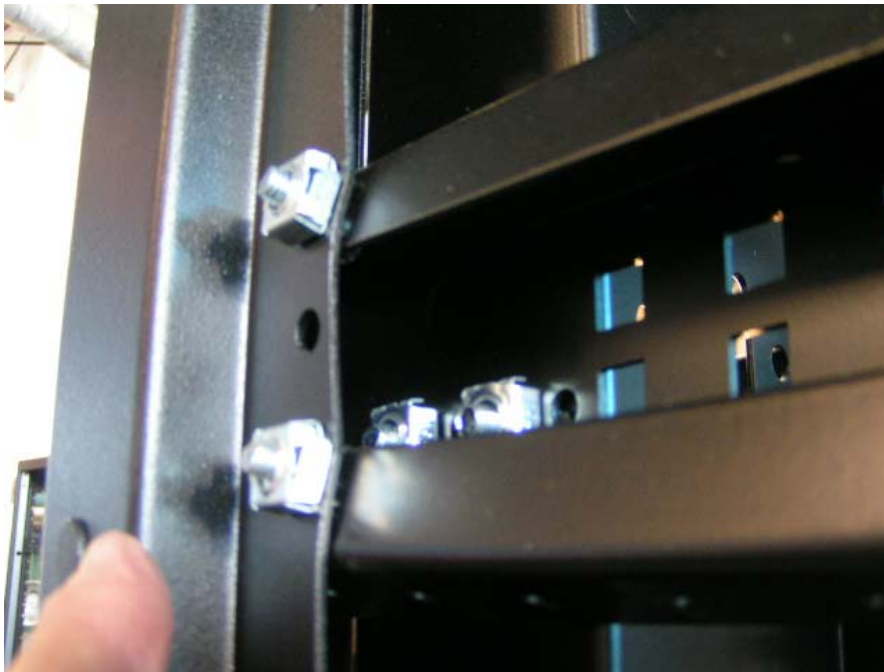
Photo 12: Distortion of the vertical corner frame and horizontal side rails.

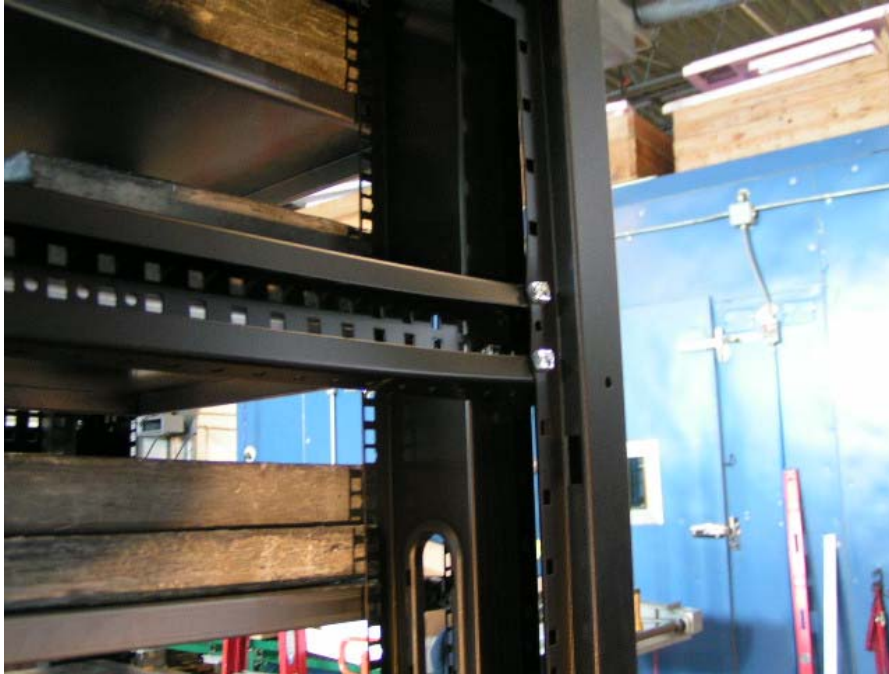
Photo 13: Distortion of the vertical corner frame and upper horizontal side rail.

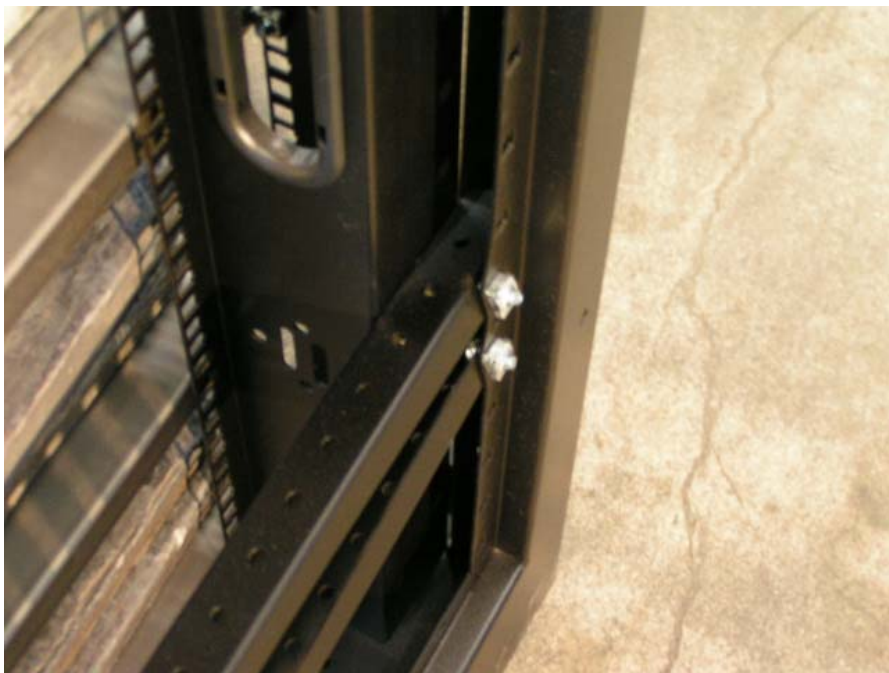
Photo 14: Distortion of the vertical corner frame and lower horizontal side rail.
