TEST REPORT NO.: DTB04R09-0989, REVISION A  
DAYTON T. BROWN, INC. JOB NO.: 410215-00-000

CUSTOMER: IMS ENGINEERED PRODUCTS, LLC  
1 INNOVATION DRIVE  
DES PLAINES, IL 60016

SUBJECT: MEDIUM WEIGHT HAMMER SHOCK TEST CONDUCTED ON ONE  
ENCLOSURE, SERIAL NO. DTB#1

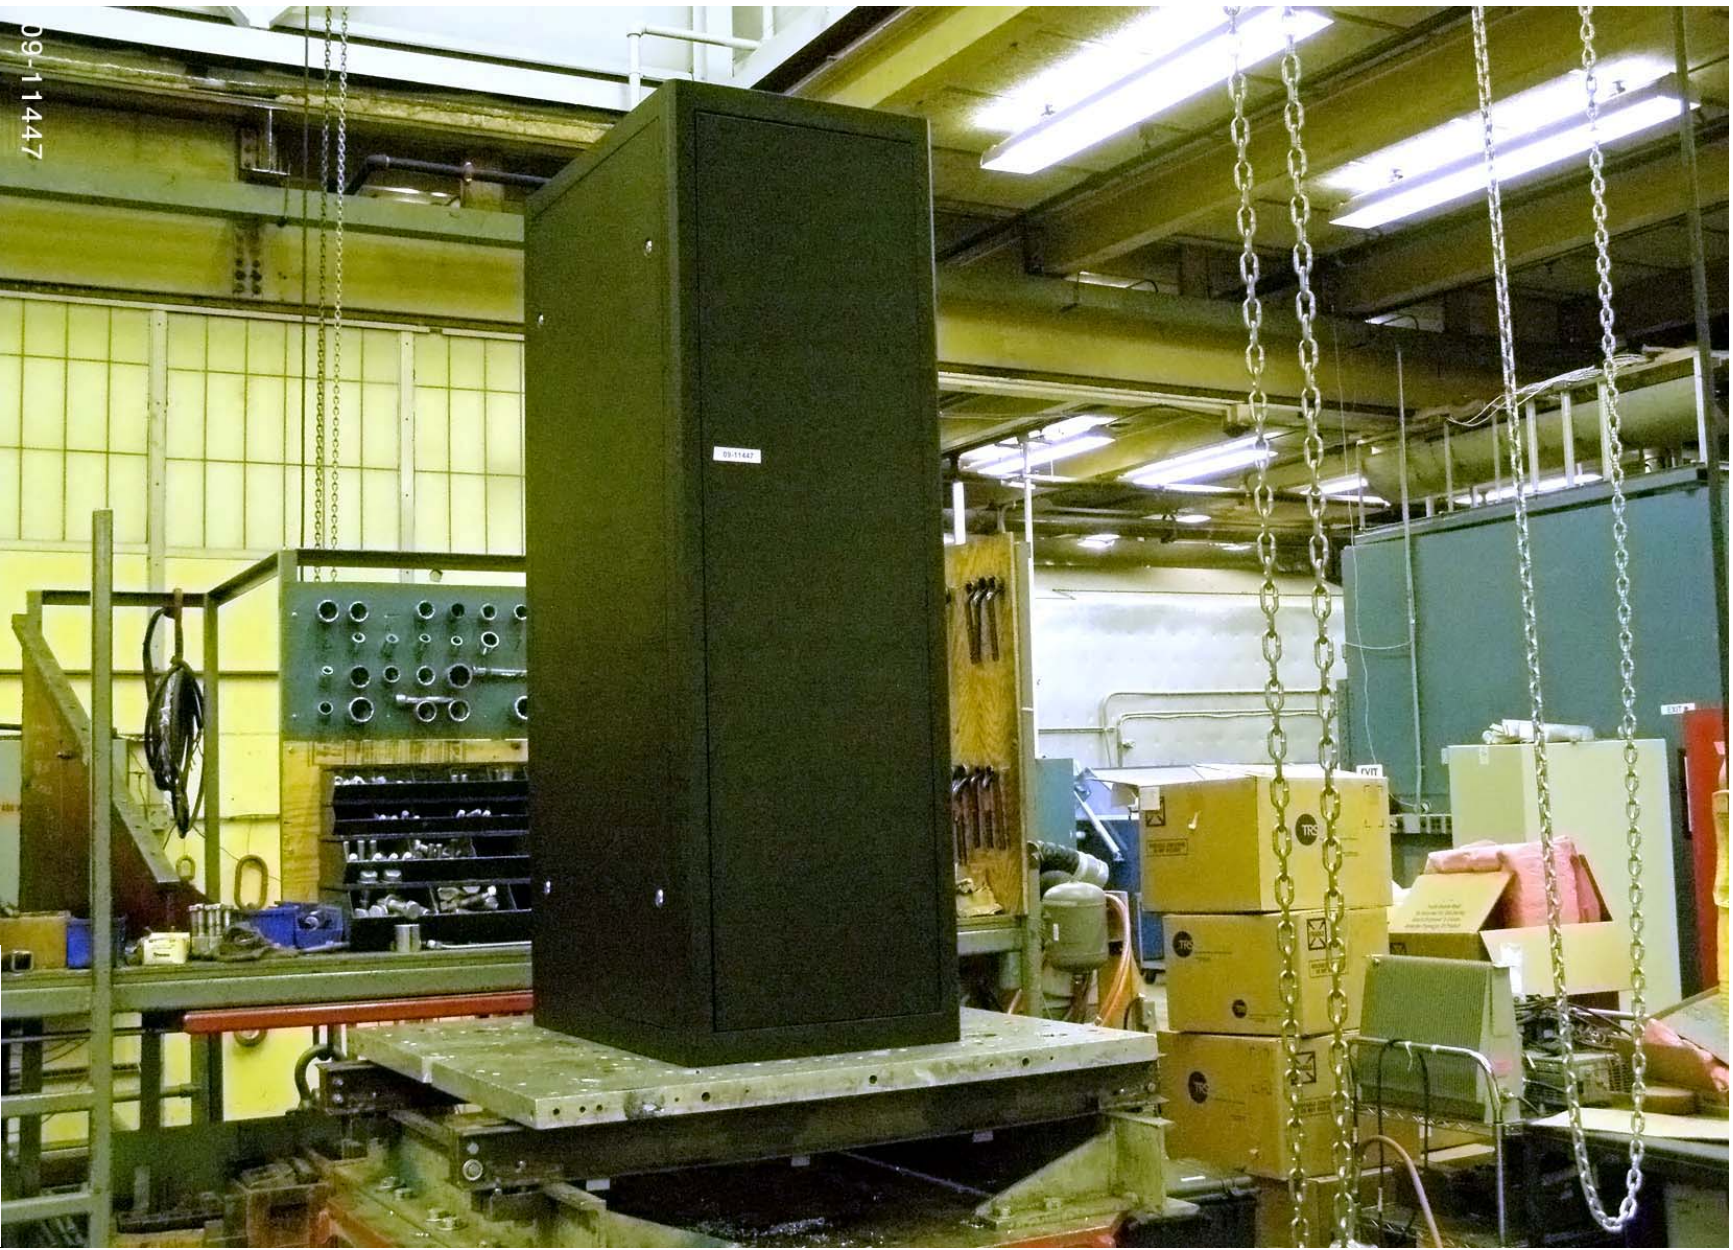
PHOTO 1

TYPICAL VIEW OF THE TEST ITEM SETUP IN THE VERTICAL CONFIGURATION FOR THE

MEDIUM WEIGHT HAMMER SHOCK TEST

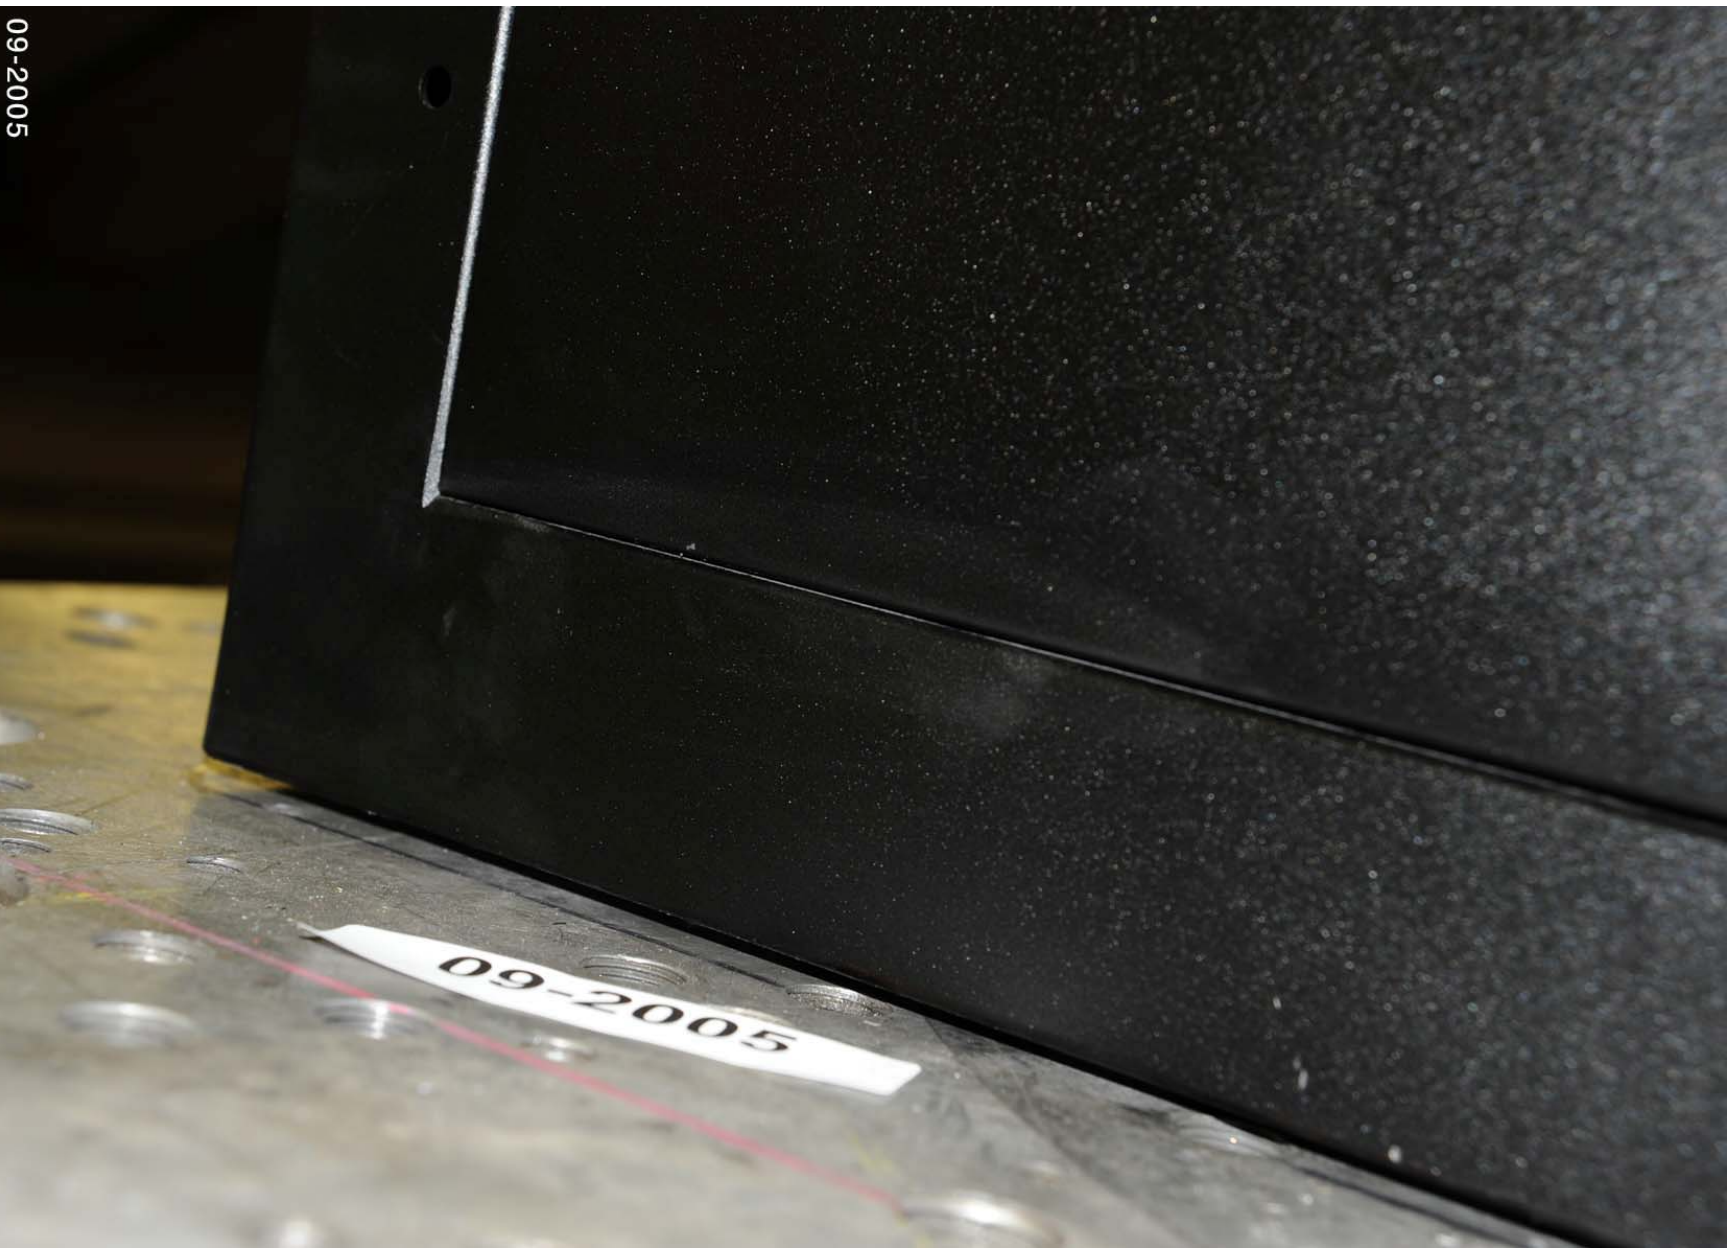
6 JULY 2009  
PHOTO 2

Shock Blow No.	Orientation	Hammer Drop Distance (ft)	Table Travel Distance (in)
1	Vertical	1.0	3.0
2	Vertical	2.0	3.0
3	Vertical	2.0	1.5
After Shock Blow No. 3, a visual inspection revealed that the panel on the right side of the test item was slightly deformed at the bottom front corner (see Photo 2).			
4	30° Back Down	1.25	3.0
5	30° Back Down	2.25	3.0
After Shock Blow No. 5, a visual inspection revealed that the panel on the left side of the test item was slightly loose at the bottom rear corner (see Photo 5).			
6	30° Back Down	2.25	1.5
7	30° Side Down	1.25	3.0
After Shock Blow No. 7, a visual inspection revealed that the panel on the left side of the test item was slightly loose at the bottom rear corner.			
8	30° Side Down	2.25	3.0
9	30° Side Down	2.25	1.5

TESTED FOR IMS ENGINEERED PRODUCTS, LLC  
ITEM: ENCLOSURE  
VIEW OF SLIGHT DEFORMATION OF THE TEST ITEM AFTER SHOCK BLOW NO. 3  
JOB NO. 410215-00-000  
DTB04R09-0989

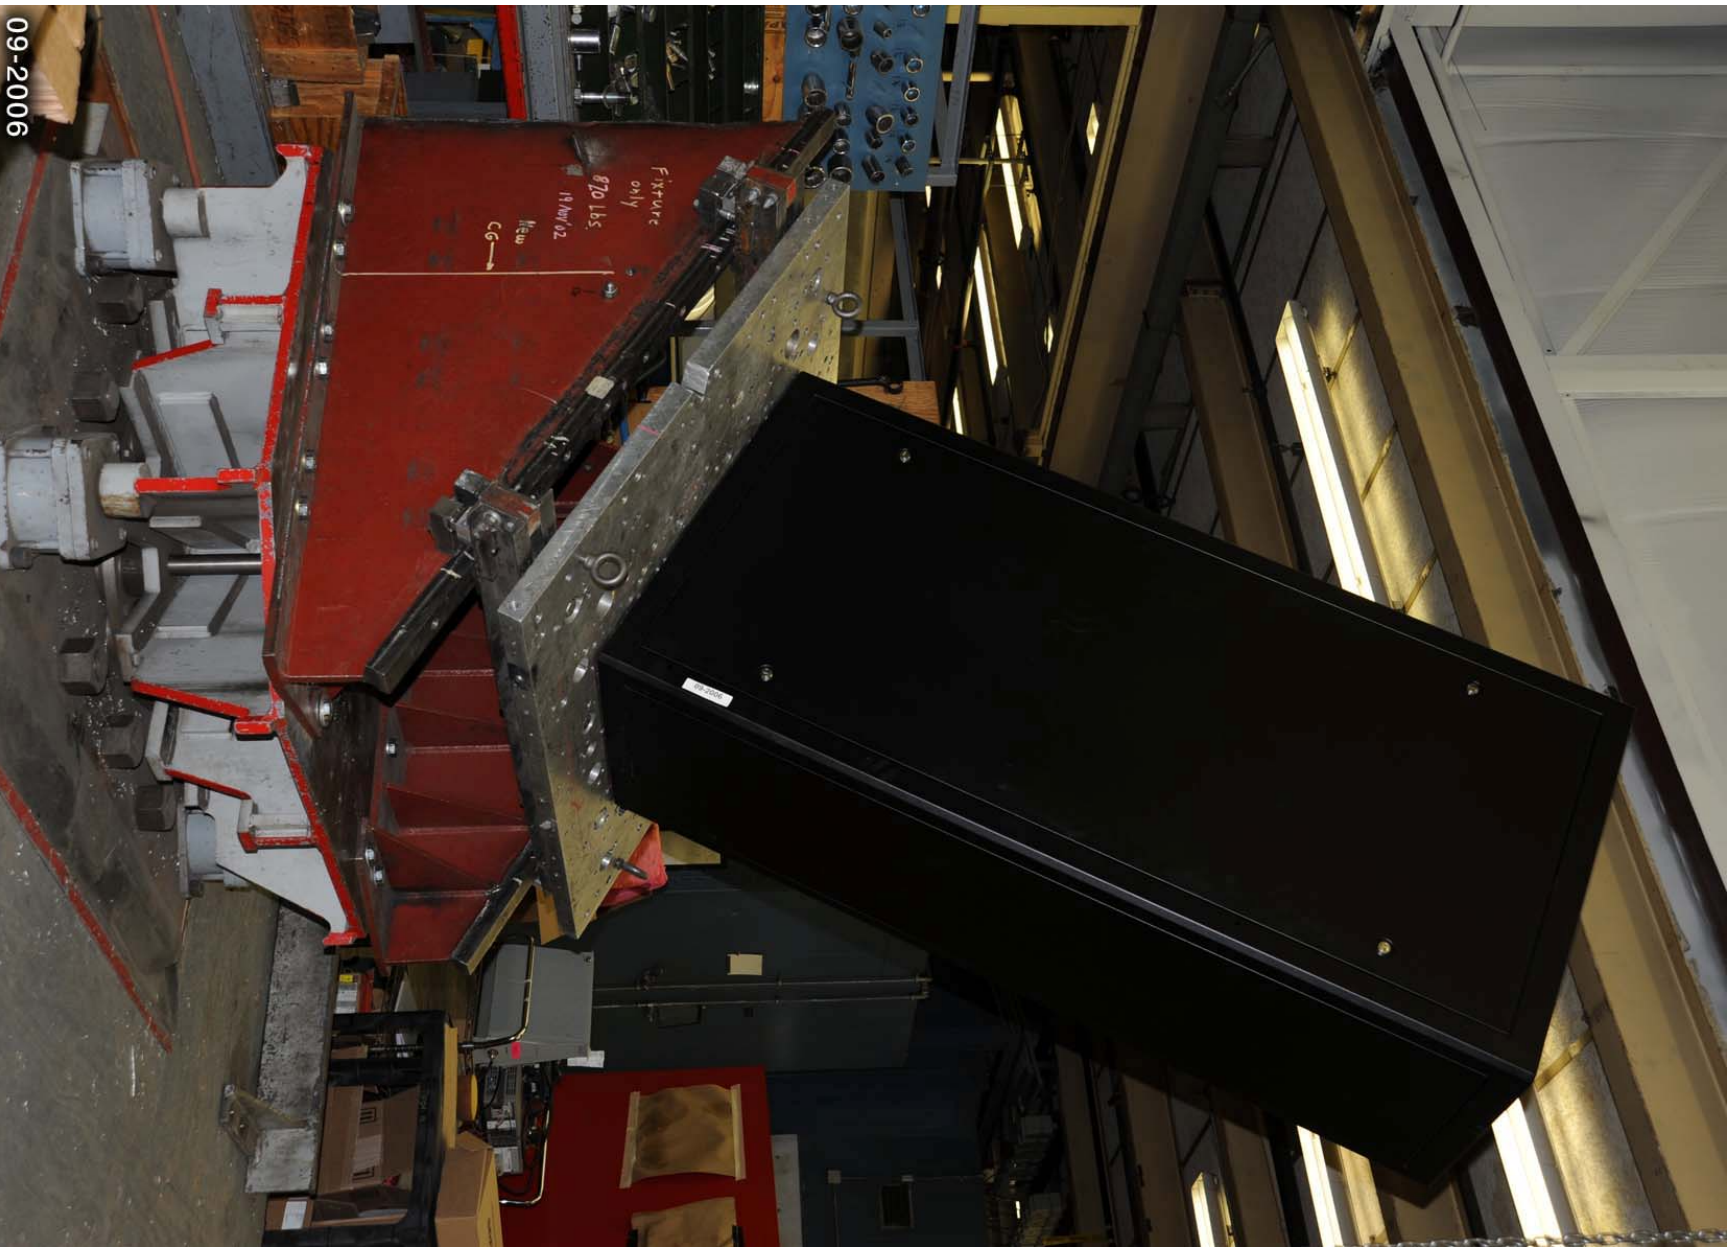
PHOTO 3

TYPICAL VIEW OF THE TEST ITEM SETUP IN THE 30° BACK DOWN CONFIGURATION FOR THE

MEDIUM WEIGHT HAMMER SHOCK TEST

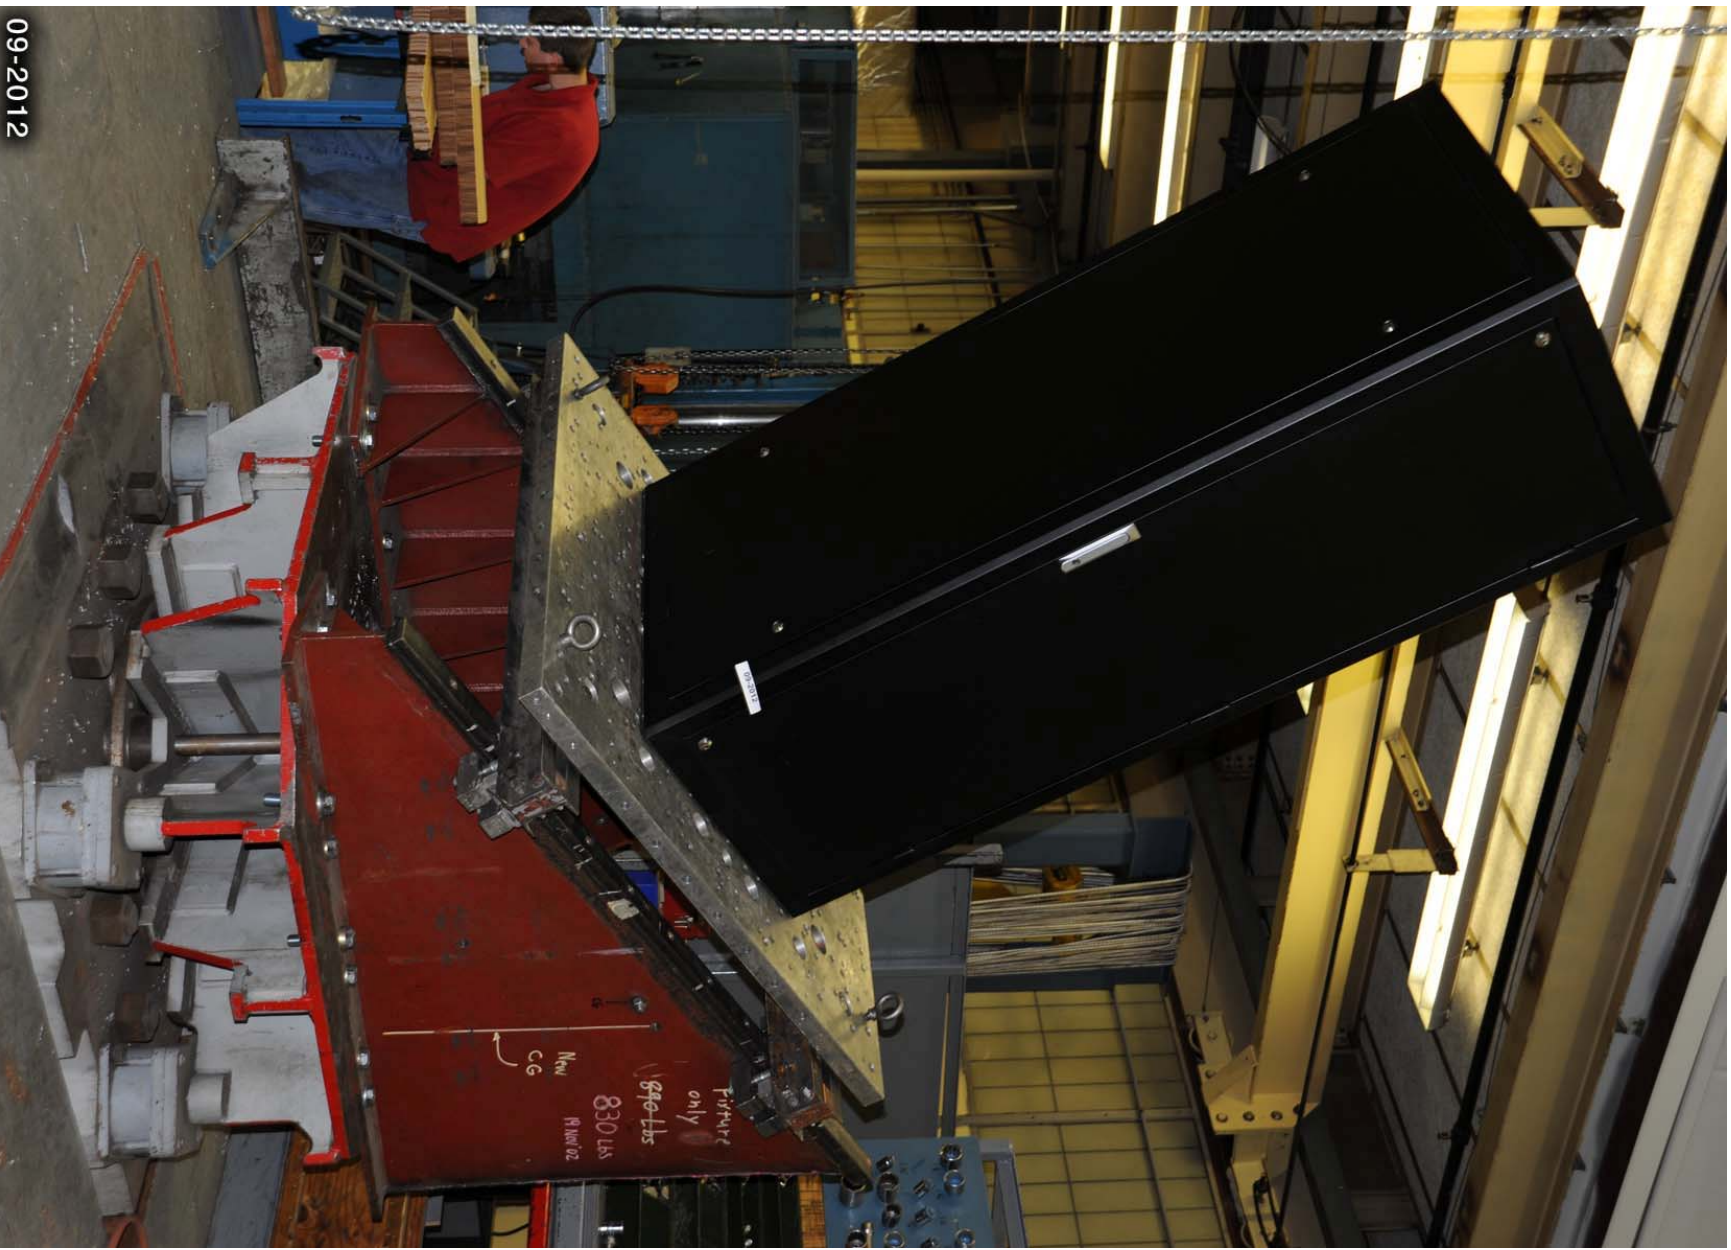
PHOTO 4

TYPICAL VIEW OF THE TEST ITEM SETUP IN THE 30° SIDE DOWN CONFIGURATION FOR THE

MEDIUM WEIGHT HAMMER SHOCK TEST

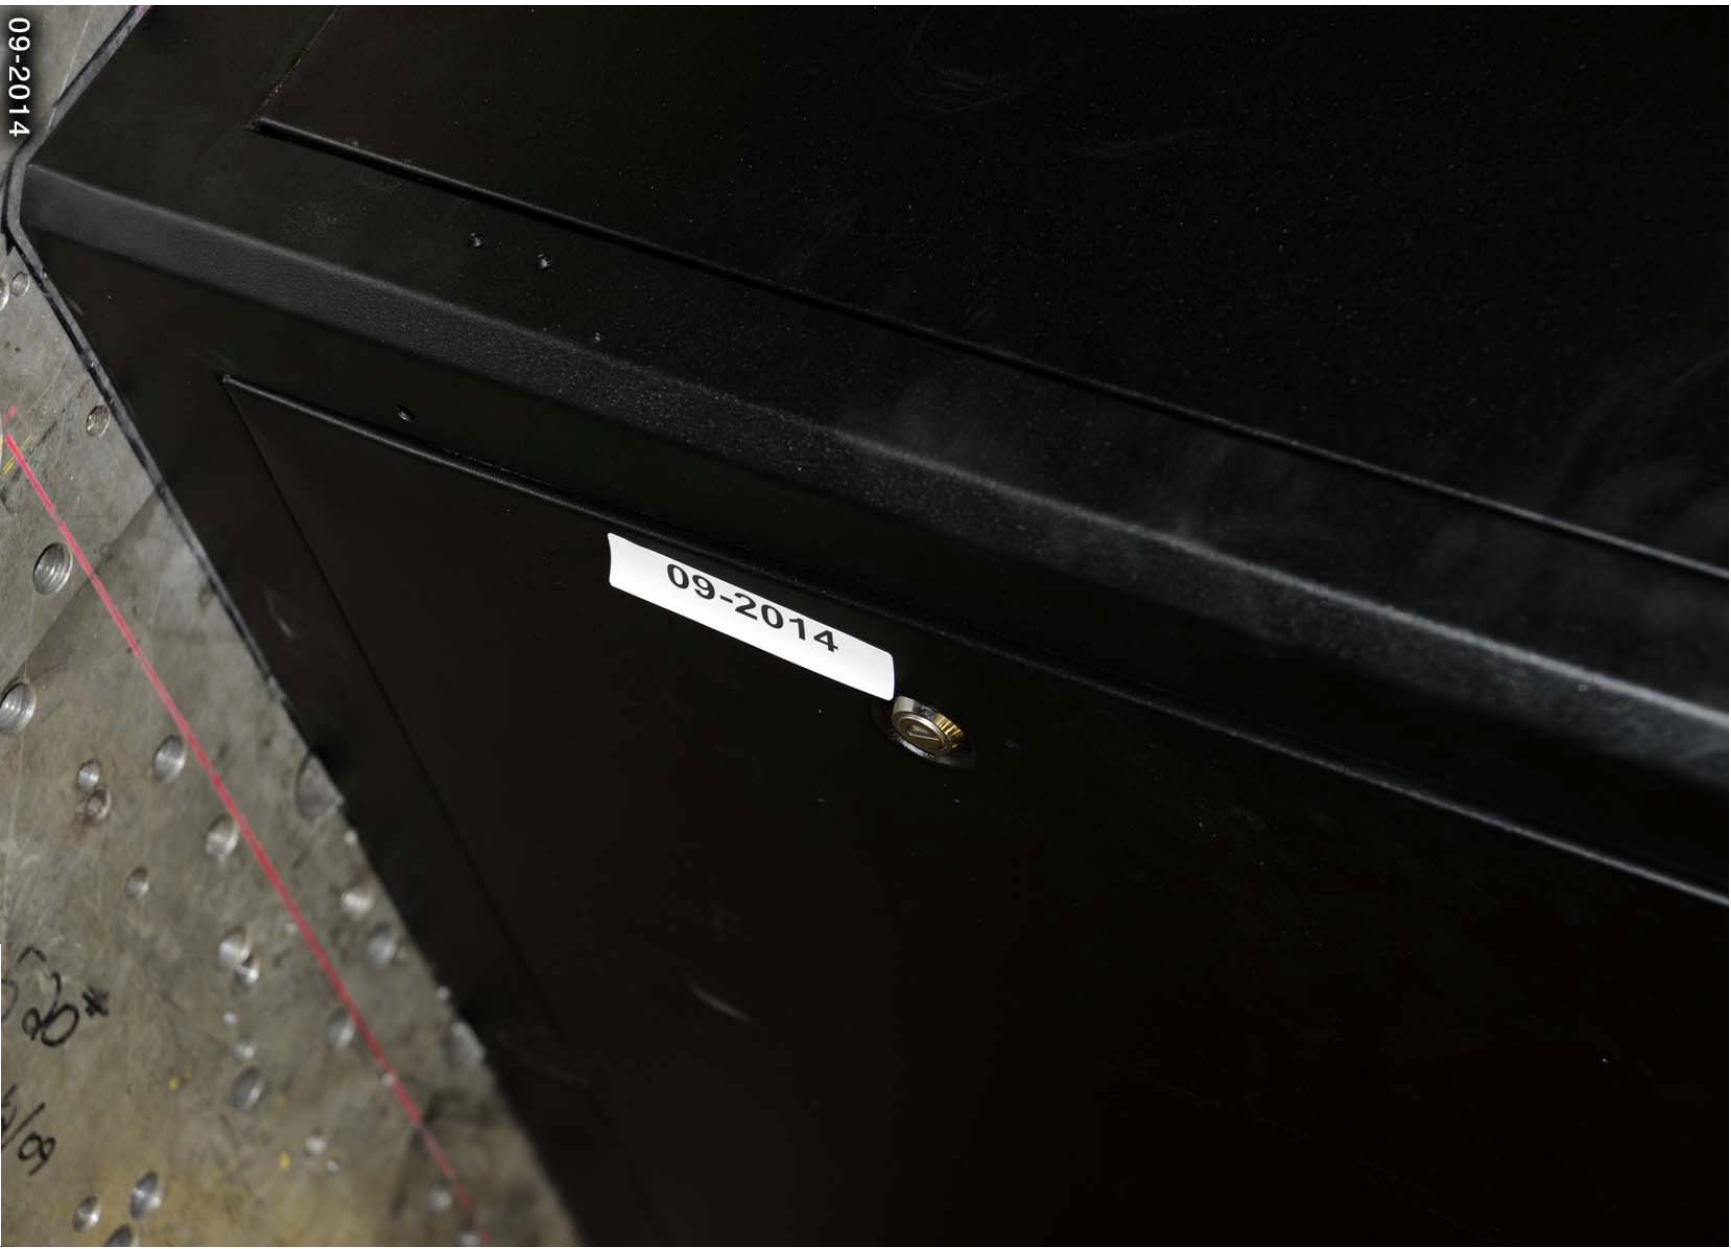
6 JULY 2009  
PHOTO 5

TESTED FOR IMS ENGINEERED PRODUCTS, LLC  
ITEM: ENCLOSURE  
VIEW OF THE BOTTOM REAR CORNER OF THE LEFT SIDE PANEL, WHICH WAS SLIGHTLY LOOSE  
AFTER SHOCK BLOW NO. 7  
FILE NO. 09-2014  
ENCLOSURE 1  
JOB NO. 410215-00-000  
DTB04R09-0989

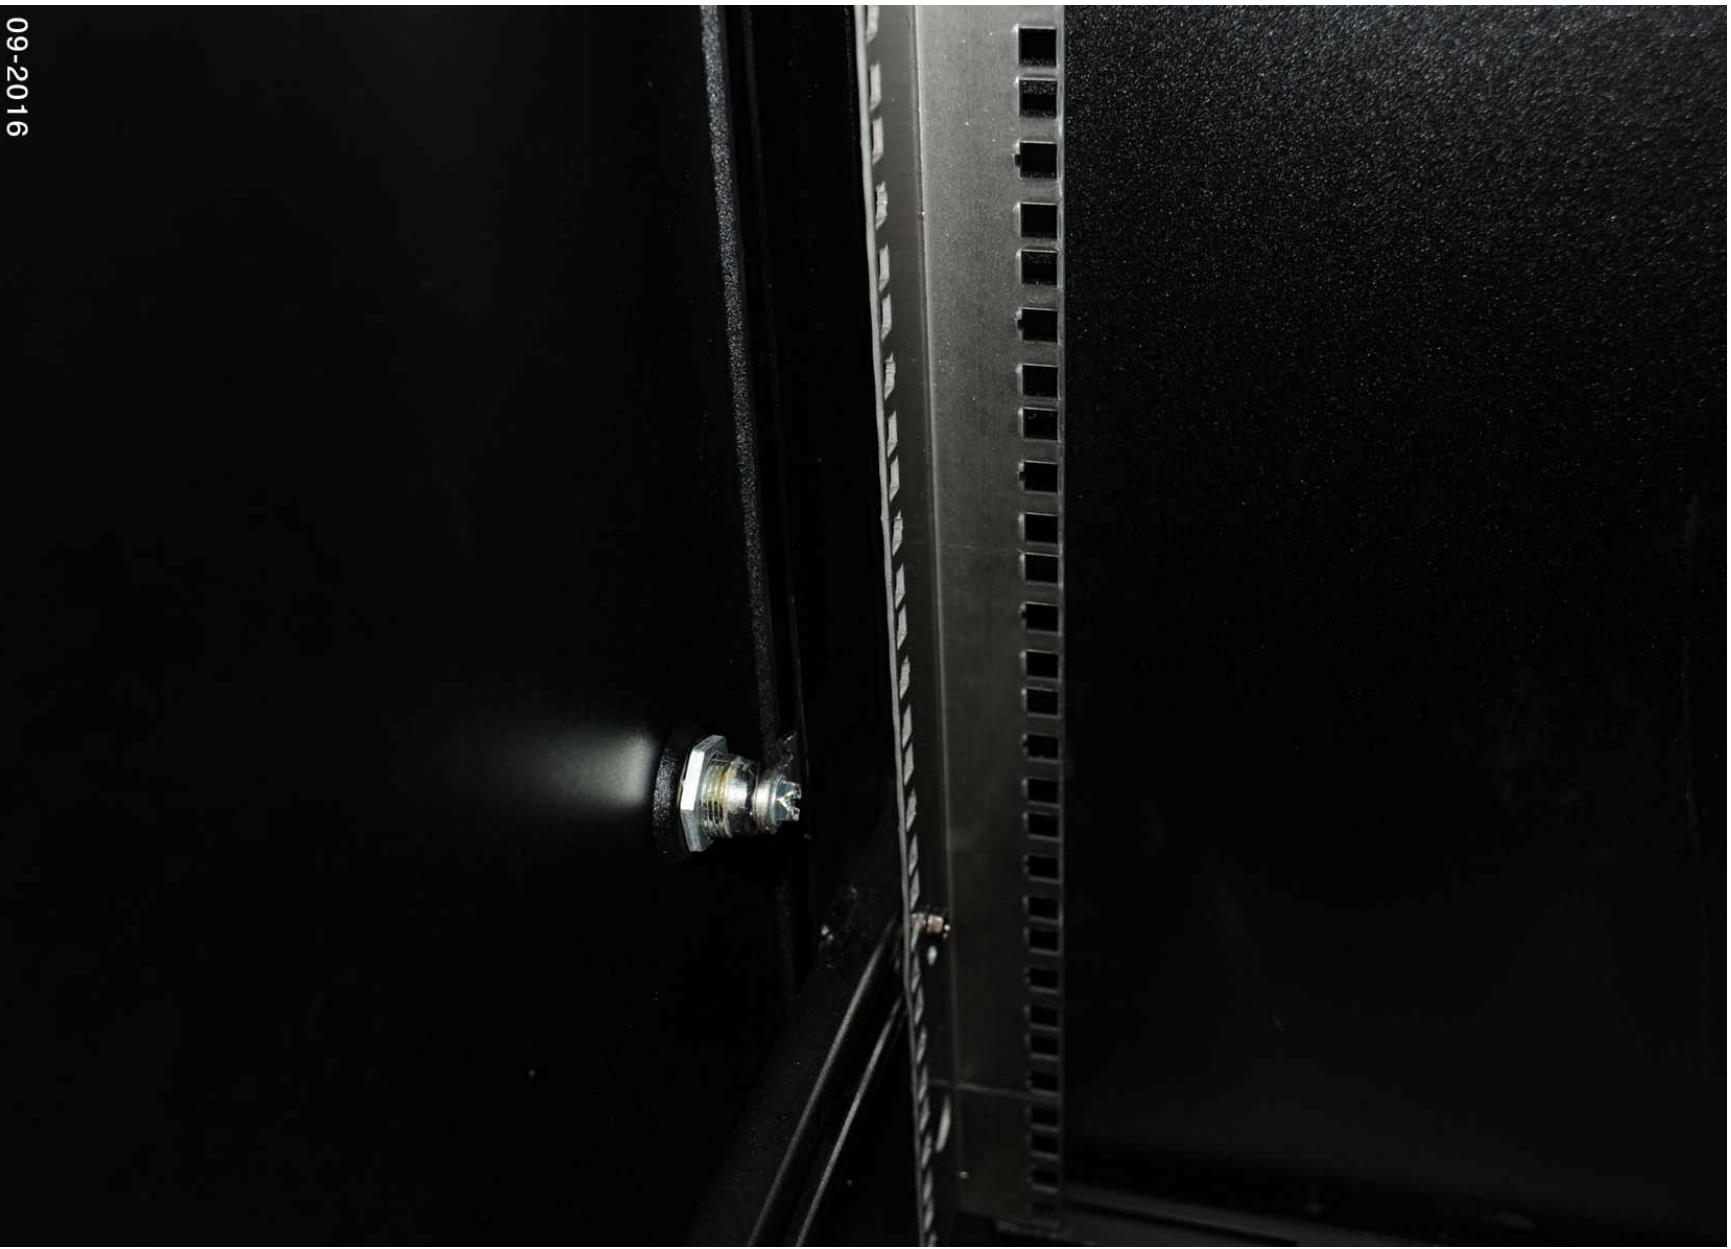
PHOTO 6

A post-test visual inspection of the test item revealed that, in addition to the anomalies noted in the table above, the left side bottom rear lock was slightly bent (see Photo 6).

VIEW OF THE LEFT SIDE BOTTOM REAR LOCK WHICH WAS SLIGHTLY BENT

AFTER SHOCK BLOW NO. 9
